North Carolina Groin Installation

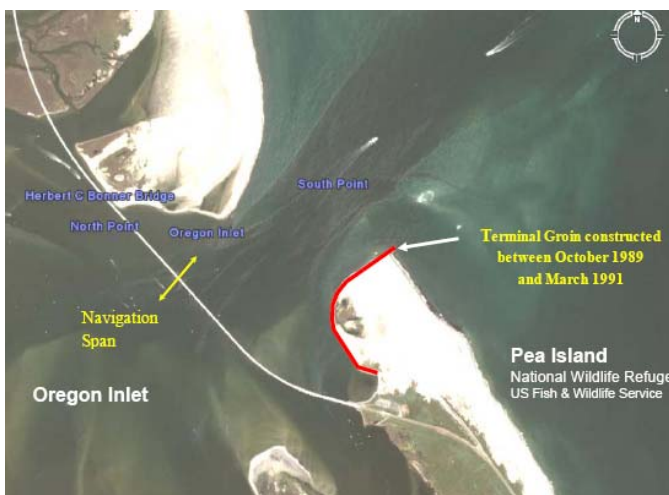
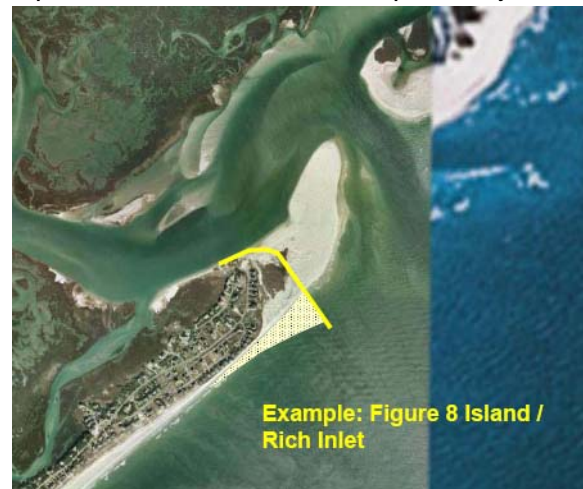
These figures show the proposed Figure 8 experimental groin and a similar groin already built at the Oregon Inlet. Although every groin will yield different results, the experience from Oregon Inlet provides

some guidance for what is likely to occur should the proposed Figure 8 groin be constructed. At the Oregon Inlet groin, erosion from the hard structure has required 7.7 million cubic yards of nourishment sand to be placed down-drift along Pea Island to counteract its shoreline

retreat. This is a large amount over 16 years and the current erosion rate is greater than the pre-groin natural erosion rates.

Recently, movement to install a terminal groin at the north end of Figure 8 Island has spurred a heated debate. The groin proposed for Figure 8 Island is intended to trap sand and widen the beach in front of a dozen threatened homes. In the process, however, it will deprive adjacent down-drift (to the south) beaches of sand and accelerate erosion, as has been shown at many places before.
